# Fisher Insight

## HISTORIC AQUARIUM USES LASER SCANNING TO SUPPORT RENOVATION

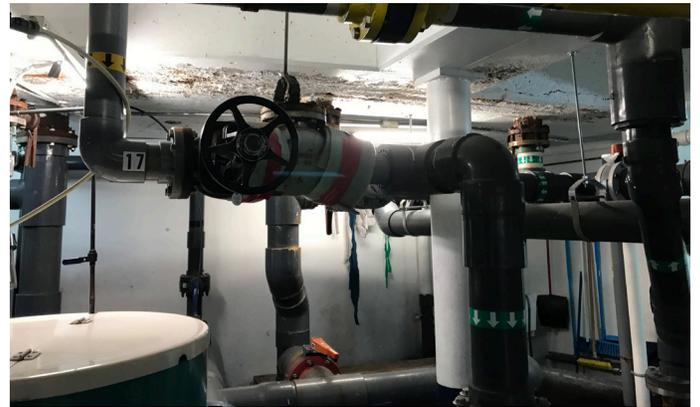
*Identifying variations in the subterranean ceiling would have taken an immense amount of time to obtain the optimum quality of data if attempted manually.*

Given the historic nature of the aquarium and its importance as an incubator for economic growth in the Niagara Falls region, the aquarium relied on the expertise of their long-term contractor and original construction team, Scrufari Construction, to continue with renovations and upgrades to the facility and evaluate conditions for future development. As Scrufari began evaluating the existing conditions around the main arena tank holding thousands of gallons of water and the underground secondary tank where animals are temporarily relocated during routine cleaning, the extent of the damage attributed to saltwater became apparent. Increasingly unforgiving and damaging, particularly to concrete, saltwater had caused extensive spalling and pipe damage to the underground ceiling of the tank.

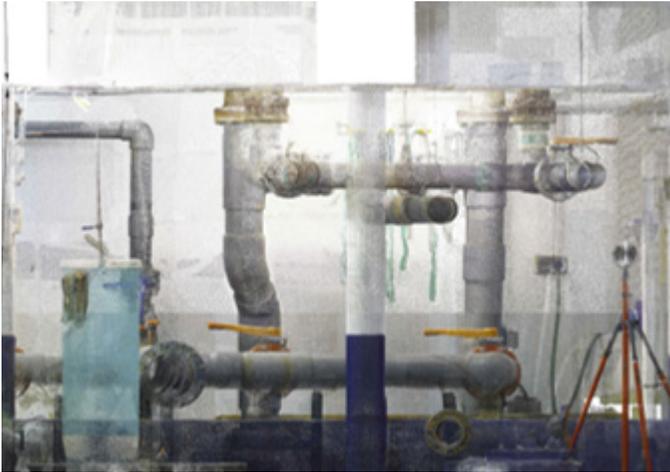
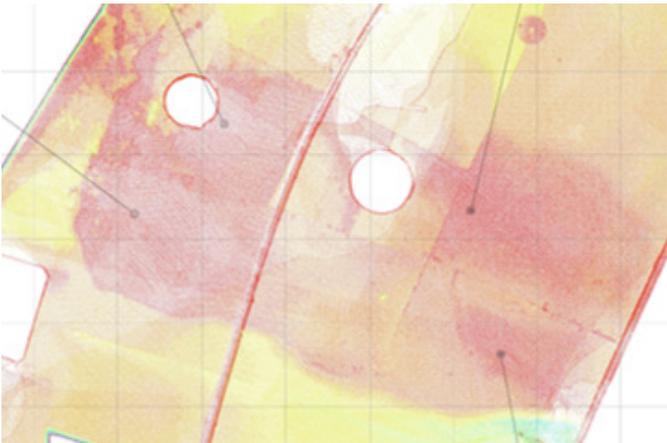
*Digital/laser scans of the filter tank ceiling area identified areas of deterioration in the ceiling.*

a digital/laser scan of the filter tank ceiling area. The scan would ultimately produce a color topographic image with multiple views and detailed drawings of the face of the compromised concrete, identifying specific deterioration, depth of spalling, and loss of material in the concrete structure.
